Level playing field

Kevin Dare, managing director, FACE Consultants Ltd and a member of the Concrete Society working group on floor regularity, looks at the new flatness standards for concrete floors.

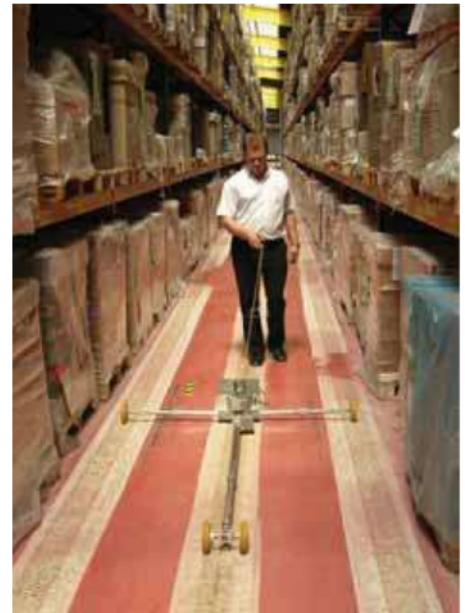
A Concrete Grinding operative using a profileograph to measure floor flatness.

TR34 edition 3 also proposes a new method for surveying defined movement areas, using a profileograph that simulates the dimensions of the trucks to be used. The profileograph produces a continuous profile of the floor surface in relation to the specification as it travels along the wheel paths of the lift truck, effectively recording the regularity of the floor as a truck would experience it.
