COGRI GROUP

COGRI NEWS

JUNE 2011

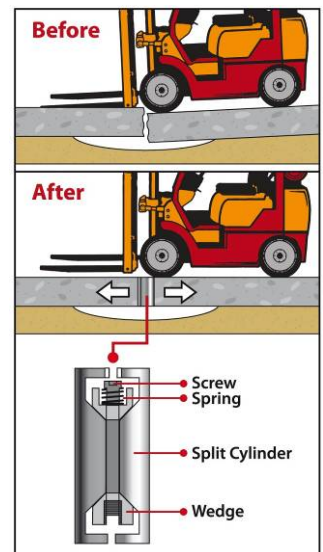
The CoGri Joint Stabiliser (CJS) is a fast, cost-effective method for eliminating rocking slabs. CJS is a split aluminium cylinder (3" diameter, 7" long) containing a screw and wedge torque mechanism. When inserted between two slabs and expanded the pressure provides the interlock needed to restore load transfer and virtually eliminates harmful slab movement. The spring-like mechanism allows it to expand and contract with the slab as it undergoes normal slab movement due to temperature changes. This gives users year after year of superior performance. CJS comes in different sizes, 200mm, 175mm and 150mm depending on the slab depths.

CoGri Joint Stabiliser installed

Alan Yuill, Director of CGFS, "We have already installed CJS at a warehouse in Northampton for a global logistics company. The problems associated with a rocking slab were soon rectified with 14 stabiliser cans located, cored and set to torque in less than 2 hours. The client was running MHE over the repaired joints within 5 minutes of the work being completed. In total, this section of the floor was only out of action for approximately 2 hours. We are really excited about the benefits this quick and easy repair method can bring to a customers warehouse operation."

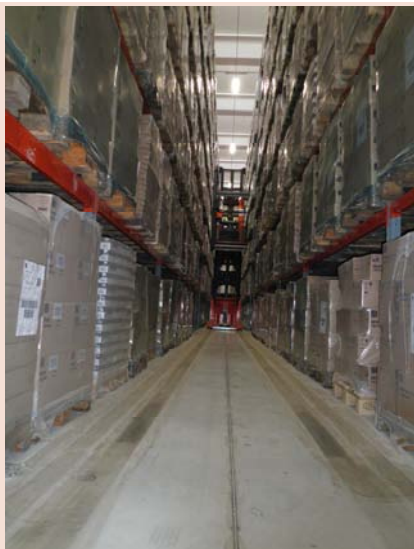
Ground path and fully operational aisle

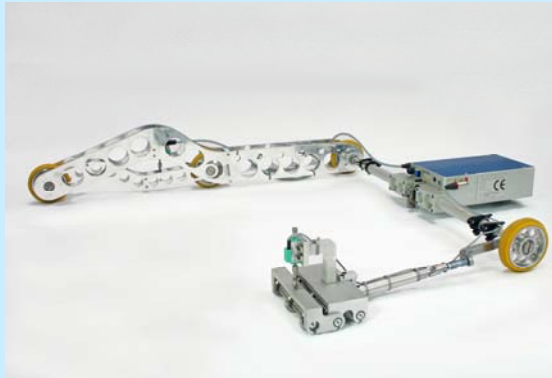
Face Consultants (Face) are now able to offer floor surveys to the recently introduced VDMA guidelines with the introduction of the Face 'Fx'-meter as an attachment to its current Face Digital DIN 15185 Profileograph. This now enhances the family of Face Digital floor surveying equipment which already

Face Digital DIN 15185 Profileograph fitted with 'Fx' meter (VDMA)

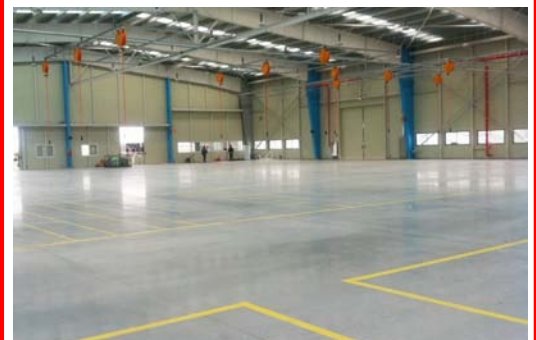
Photo below: Recently completed SFRC SOG floor which is being used by a car manufacturer to store vehicles made in Korea prior to shipping overseas.

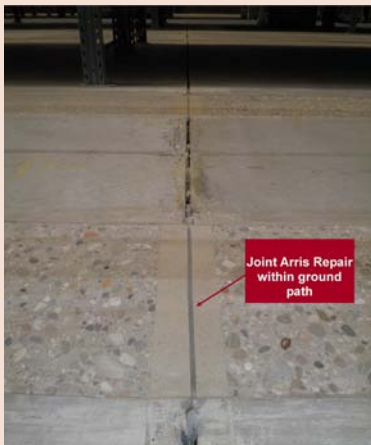
Joint Arris Repair within ground path

Concrete Grinding were also asked to carry out floor joint repairs in the facility. With assistance from CG Flooring Systems Ltd, the team carried out 110 metres of joint arris repairs and 1200 metres of joint reseal repairs within the 400mm ground path to cater for the wheels of the trucks. This

resulted in an additional cost saving as the whole aisle width did not have to be repaired. The saw cut joints were resealed every 4 metres along each aisle. 50 metres of joint repairs were also completed within door openings between the 7 separate compartments. A large portion of the joint repairs were completed immediately after Christmas, during the client's shutdown, ahead of grinding work.

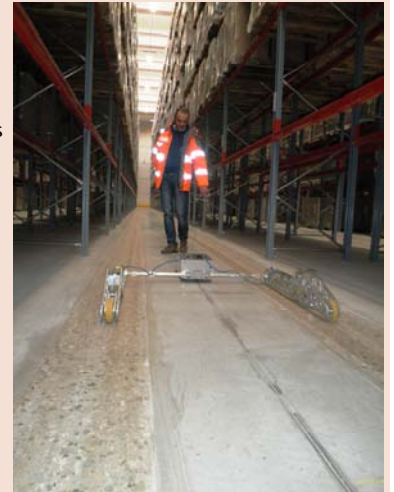
Trimmer S.r.l. testing floor flatness using the FACE DIN Profileograph

After grinding, Trimmer S.r.l. re-surveyed the aisles using the FACE DIN Profileograph to prove the floor flatness specification had been met.
