Floor Joint Repairs

CG FLOORING SYSTEMS LTD
Specialists in Industrial Flooring

Joint "Reseal" Repair

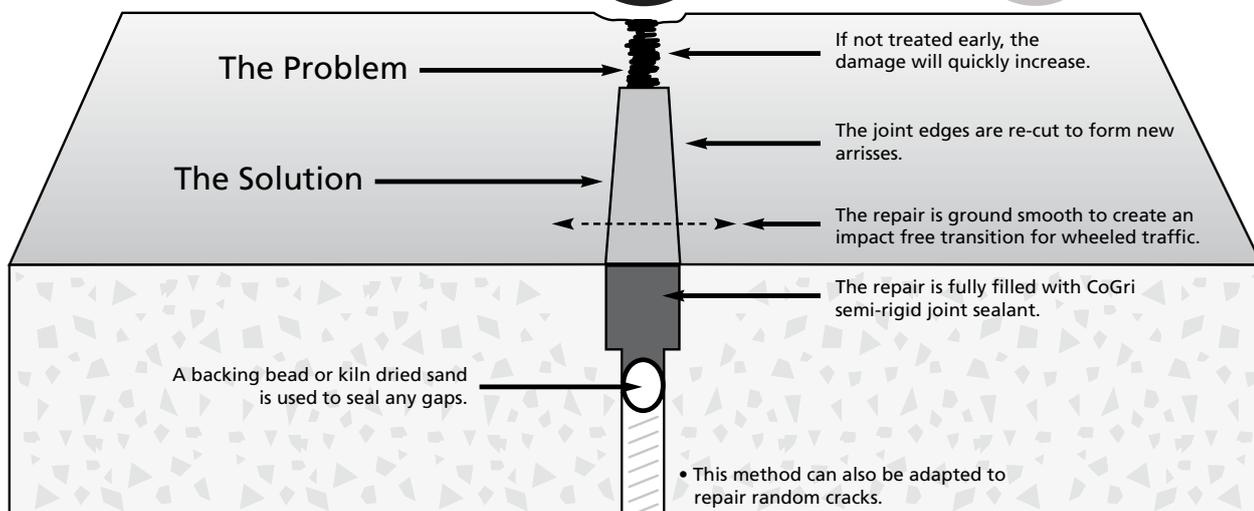
The Solution:

Damage to joint is reduced/prevented by implementation of semi-rigid joint sealant. Warehouse traffic experiences smooth transition across joint.

Using the joint reseal detail (below) in conjunction with CoGri semi-rigid joint sealant, we can reduce or even prevent further edge spalling. However, this relatively simple repair process can only be utilised if the edge damage is detected at an early stage. If more serious damage has already occurred we would need to re-construct the joint 'arrisses' by using the repair method overleaf.

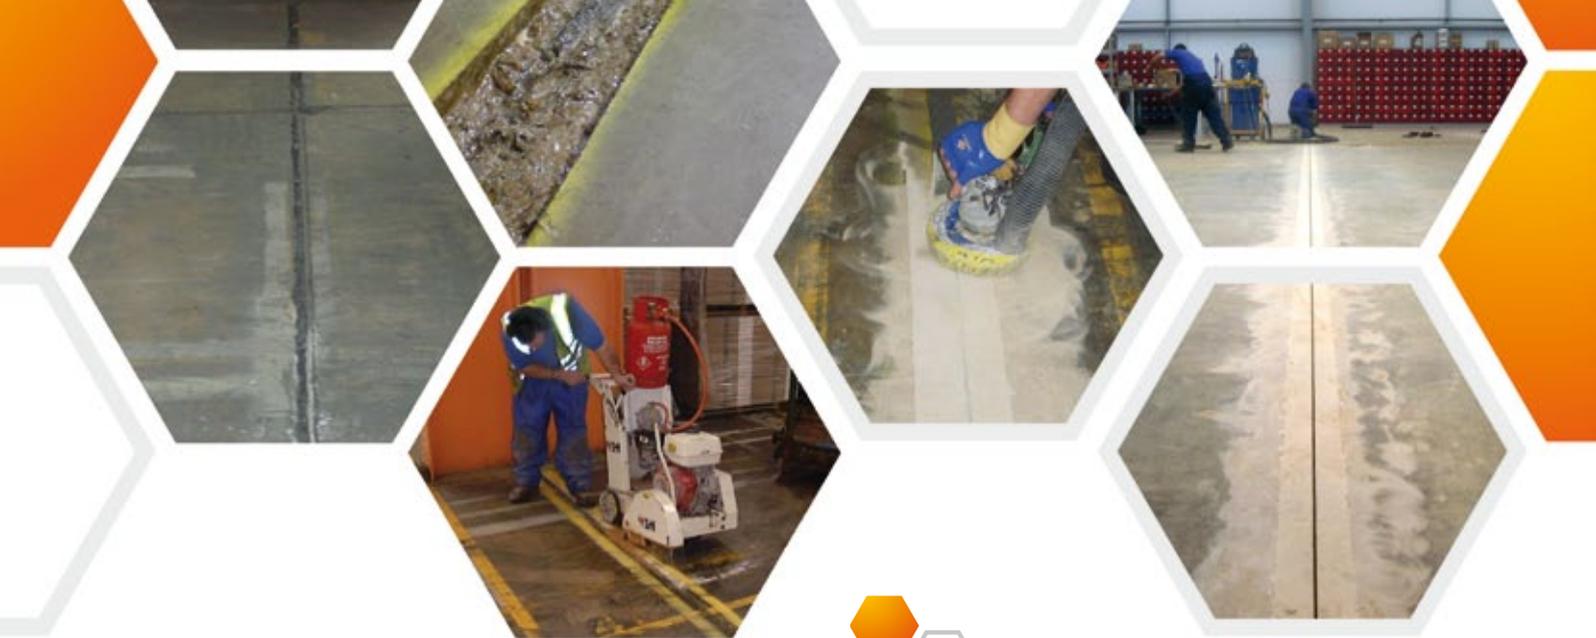
Materials Handling Equipment functions more productively on floors that are smooth and interruption free.

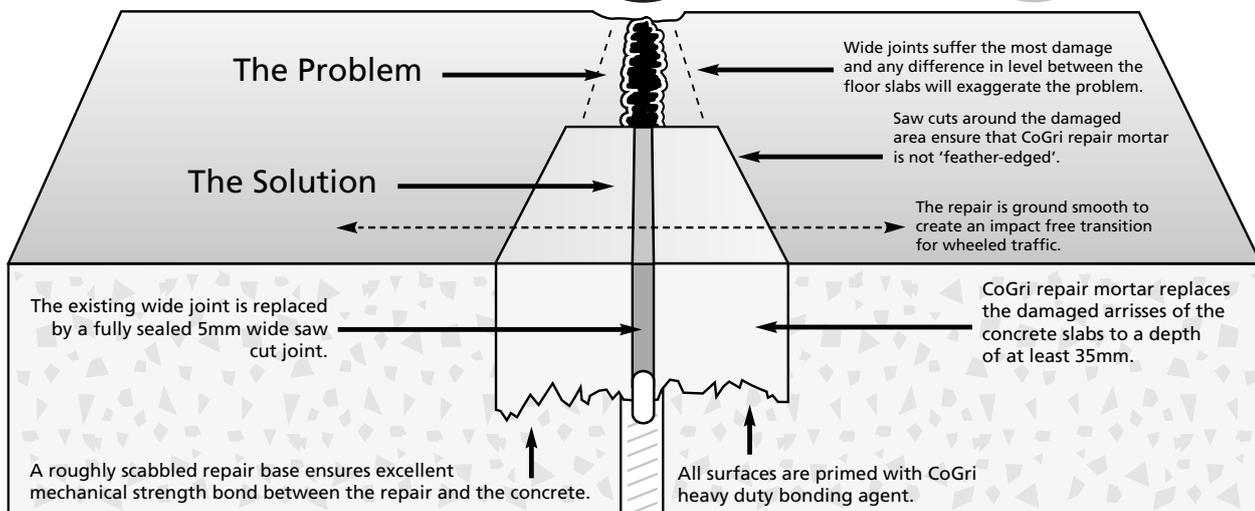
The Solution:

New extremely durable joint system provides a smooth surface on which warehouse traffic can pass, potentially reducing maintenance costs to MHE.

Wide joints increase the risk of arris spalling due to the deflection of the joint sealant under load. It is therefore important to reduce the width of the joint opening at surface level. Our tried and tested joint arris repair detail (shown below) allows a 50mm wide 'traditional expansion joint' to be replaced with a neat 5mm wide, fully sealed saw cut. Each of our repairs are ground smooth and flush with the adjacent floor surface to ensure that wheeled traffic has a smooth transition over the repaired joint.
