Fast, Low-Cost Floor Joint Repair

The specialist joint repair division of Concrete Grinding (UK) Ltd has successfully repaired the two main 24-metre transverse construction joints in a 2000m² concrete floor slab in a single week-end and at a much lower cost than alternative methods.

Client: Blum UK
Concrete Grinding
Solution: Joint Repairs

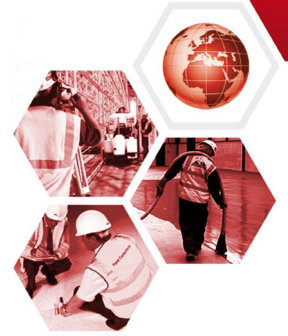
Uneven joints between the three sections of the floor slab in the warehouse at Milton Keynes run by furniture fittings distributor Blum UK were causing the wire-guided man-up trucks to frequently malfunction. CG(UK) confirmed that localised sub-base compression related to the failure of the load transfer system between the slabs was

the fundamental cause.

beneath them, cutting back the joint arrises to a depth of 50mm and then re-building the joints with a high-performance epoxy mortar. Finally, the joints were re-cut in the same position as before, filled with a semi-rigid compound, then ground to ensure a completely even surface and sealed.

Blum UK had considered carrying out major structural repairs to the slabs, which would have taken at least six week-ends and been very disruptive and expensive. CG(UK)'s solution was to stabilise the joint edges by pumping a high-strength resin foam into the void
